BUILDING THE DEVIL'S PLAYGROUND: How a Ground Improvement Program Eliminated the Need for Pile Foundations

Christian B. Woods, P.E., LEED^{AP} BD+C, Densification, Inc., Paeonian Springs, Virginia, USA
Joe C. Drumheller, P.G., Densification, Inc. Paeonian Springs, Virginia, USA
Kenneth A. Huber, P.E., Langan Engineering & Environmental Services, New York, New York, USA

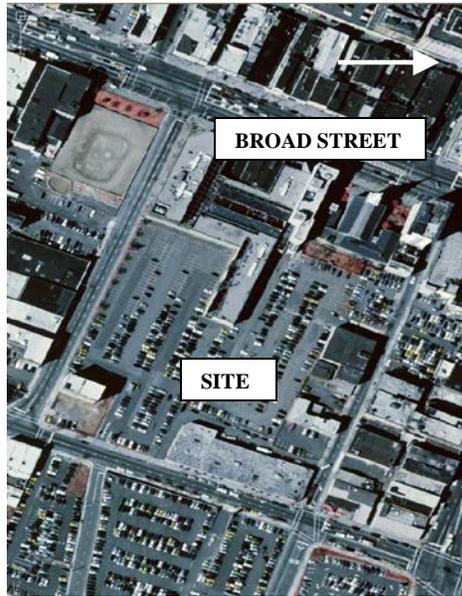
The site is located in Newark, New Jersey, and is generally bounded by Edison Place to the north, Broad Street to the west, Lafayette Street to the south, and Mulberry Street to the east. An aerial layout of the site prior to construction is shown in Figure 1.

Figure 1 – Pre-Construction Aerial of Arena Site

Prior to construction of the Prudential Center, most of the interior of the site was occupied by asphalt-paved, at-grade parking lots. The former Renaissance Mall along Broad Street had recently been demolished, and several other abandoned buildings existed around the perimeter of the site. Additionally, the alignment of Lafayette Street formerly existed across the southern end of the site; the street was

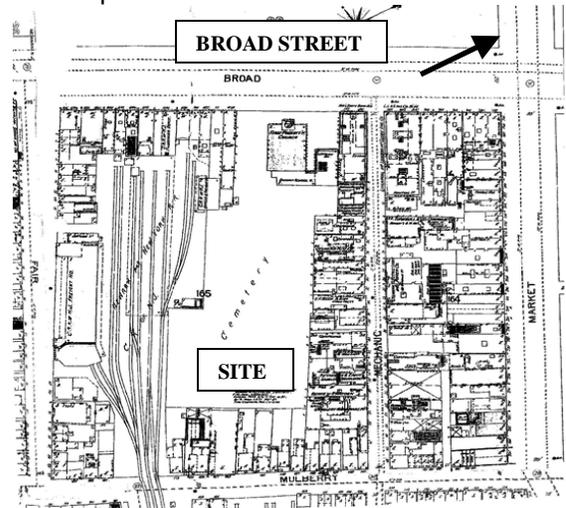
Available Sanborn maps also indicated that the southern portion of the site was once used as a rail yard for Central Railroad of New Jersey, with rails running in the east-west direction across the site. Evidence of the former railways, primarily in the form of concrete grade beams, was uncovered during excavation for the demolition of the former Renaissance Mall. A Sanborn map of the site from prior to the 1950's is shown in Figure 2.

Figure 2 – 1950's Sanborn Map of Arena Site

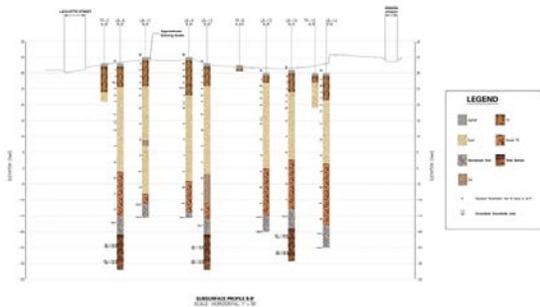
A brief description of each material encountered during the investigation phase of the project is provided below; see Figure 3 for a generalized soil profile:

Figure 3 – Generalized Soil Profile

Miscellaneous Fill – A layer of miscellaneous fill up to about 15 feet thick was encountered across the entire site. The miscellaneous fill material generally consisted of coarse to fine sand with some silt and varying amounts of gravel, cobbles, and debris, including concrete, brick, plastic, glass, and rubber. SPT N-values within the fill material range from the weight of the hammer advancing the split-spoon sampler to 100 blows over 2 inches, and averaged approximately 22 blows per foot (bl/ft). During the test pit excavations, the remnants of a below grade concrete walls, slabs, gravestones, and skeletal remains were encountered.

Sand – A layer of glacial outwash sands was encountered underlying the fill layer, and ranged in thickness from approximately 17 to 44 feet. Generally, the sand layer consisted of medium dense to dense, poorly graded, medium to fine sands, with varying amounts of coarse sand, fine gravel, and silt. Relatively thin, isolated pockets of silt were encountered sporadically throughout the sand layer. SPT N-values within the sand layer range from 7 bl/ft to 118 bl/ft, and average approximately 26 bl/ft. The lower N-values generally occurred immediately below the water table; overall, however, the N-values within the sand layer tended to increase with depth.

Glacial Till – A layer of glacial till was encountered underlying the sand layer, and ranged in thickness from approximately 3 to 24 feet. The glacial till layer generally consisted of very stiff to hard silts and medium dense to dense sands, with varying amounts of gravel, cobbles, and boulders. SPT N-values in the glacial till layer ranged from 15 bl/ft to 100 blows

Shale Bedrock – The overburden soils are then underlain by shale bedrock, the top of which was encountered at depths ranging from approximately 35 to 65 feet below existing grade (elevation -4 to -35 feet). The elevation of the top of rock generally decreases moving east across the site, towards Mulberry Street. The general quality of the rock varied, and in almost every instance, the upper portion of the rock (generally 5 feet on average) was found to be decomposed in nature.

Groundwater – Groundwater was encountered at depths ranging from 9 to 28 feet. These depths correspond to a range from elevation 5 feet to elevation 21 feet. Groundwater was observed to stabilize within the monitoring wells at depths of 18.5 to over 25 feet, corresponding to elevations between about 12.5 to 5 feet. It is likely that the groundwater encountered at shallower depths was perched on buried obstructions within the fill layer.

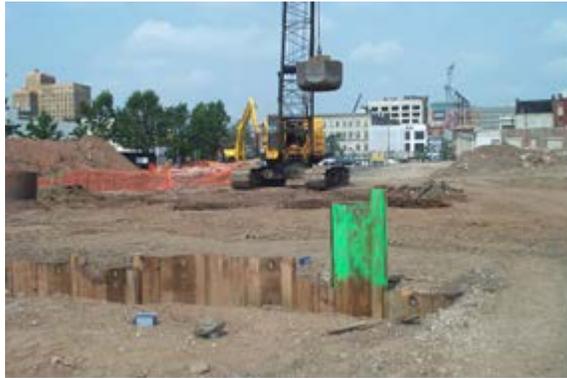
The test section implemented was approximately 50 feet square in plan area, and was located in the southeastern corner of the arena, at one of the super column locations and in the location of the worst soil conditions. The test section consisted of a 15-ton weight being dropped from a height of 55 feet, over a three pass system, as previously described. It was important to mimic the program which was to be carried out during the production work. A photo of the test section work in progress is shown in Figure 4.

Figure 4 – Photo of Test Section Work

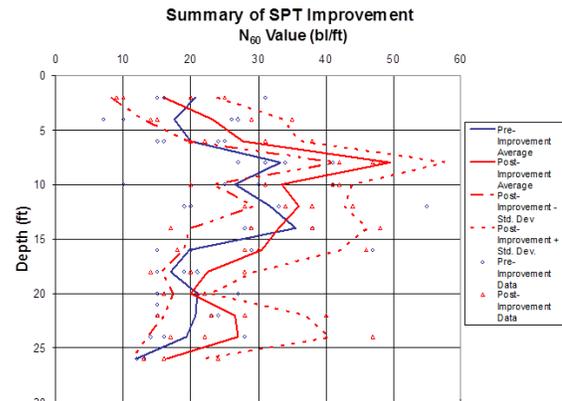
- Average SPT N-values within the upper 25 feet increased from 26 bl/ft to 29 bl/ft, but most importantly, the minimum N-values observed increased from 7 bl/ft to 14 bl/ft. A figure showing the pre-

and post-improvement averages is shown in Figure 5.

Figure 5 – SPT N-value Comparison

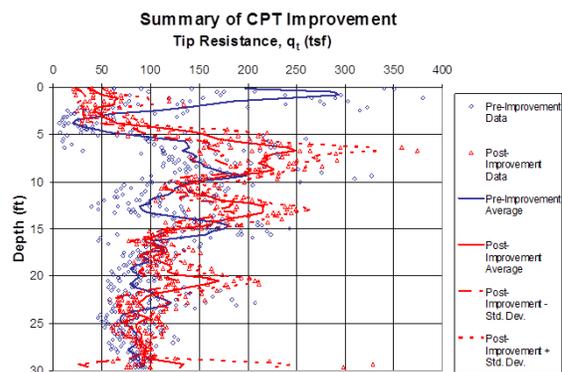
- Average CPT tip resistance values within the upper 30 feet increased from 113 tsf to 129 tsf. A figure showing the pre- and post-improvement averages is shown in Figure 6.

Figure 6 – CPT Tip Resistance Comparison

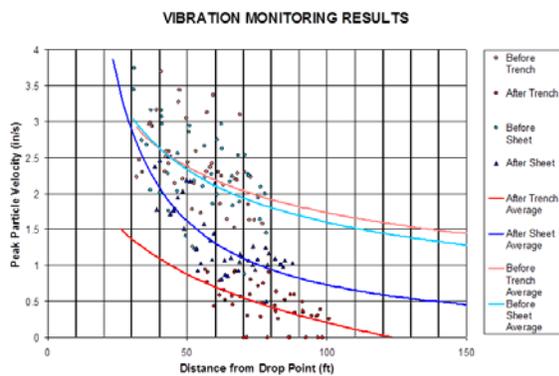
A plot showing the vibration levels both in front and behind the sheet pile wall and seismic cut-off trench are shown in Figure 7. Overall, the cut-off trench was observed to be more effective

than the steel sheet pile wall at reducing vibration levels during the dynamic compaction work. Specifically, vibration levels were reduced by the cut-off trench and sheet pile wall 70% and 35%, respectively. As a result, the recommendation was made to move forward with seismic cut-off trenches adjacent to sensitive structures, with maximum vibration levels at various elements being recommended as follows:

Figure 7 – Vibration Monitoring Data

- 1.0 in/sec near utilities;
- 0.5 in/sec near most structures;
- 0.25 in/sec near the church.

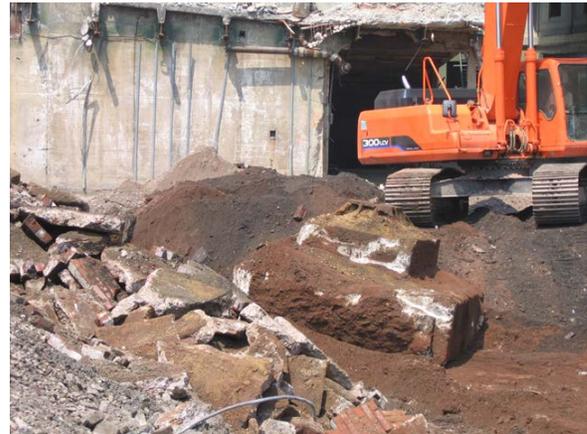
As mentioned above, portions of the site, primarily around the perimeter, were occupied with multi-story structures prior to construction. These structures, along with any below-grade levels and foundations had to be demolished and removed prior to foundation construction. Following demolition, these excavations were backfilled with structural fill as the first part of the ground improvement program. In addition to the existing structures, several below-grade structures associated with the former rail yard on site needed to be identified and removed. A photo showing a typical rail foundation that was encountered is shown in Figure 8.

Figure 8 – Typical Rail Foundations

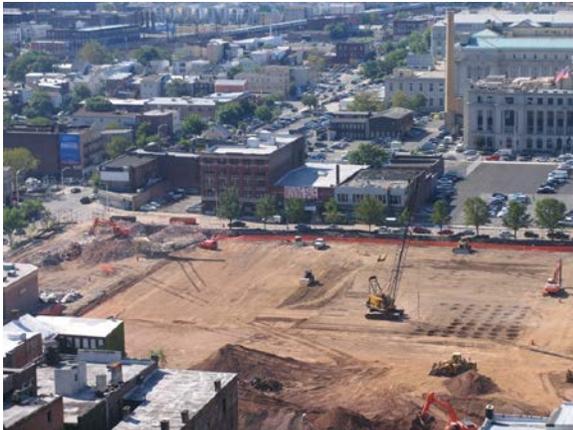
Once the archaeological excavation, demolition, and test section work were completed, the dynamic compaction production work was completed. Production work was completed in an identical manner to the test section, and observed continuously to evaluate crater depths, vibration levels, and overall ground response. Charting of the crater depths during the production phase became very important during the completion of the borings advanced to evaluate the effectiveness of the dynamic compaction program. Specifically, one area of the site demonstrated N-values which were below the minimum stated acceptance criteria of 20 bl/ft. By reviewing the crater depth information collected during the program, the area which needed to be re-pounded was easily identified and additional drops were successfully carried out. A photo taken during the production phase is shown in Figure 10.

Figure 10 – Dynamic Compaction Production

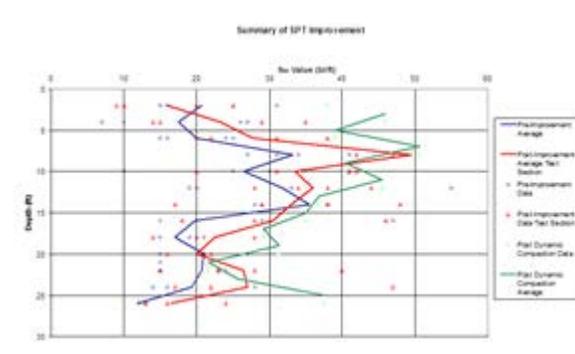
Overall, the results of the post-production testing were even more favorable than those obtained following the test section work. Specifically, an average N-value of 31 bl/ft was obtained across the site. A plot illustrating the average SPT N-values prior to construction, following the test section, and following the production work is shown in Figure 11.

Figure 11 – Post-Production Results

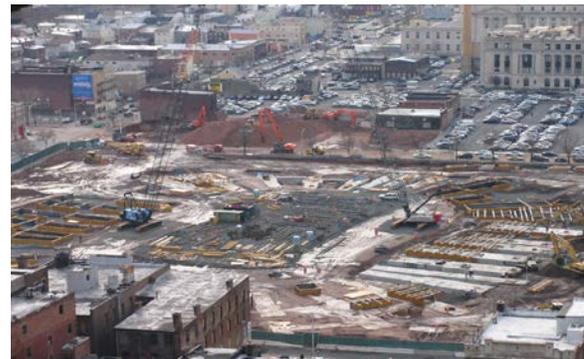
conditions. Given the size of some of the arena foundations, several days were required in some instances to erect the forms and place rebar prior to concrete placement. The bitterly cold weather at the time of much of this work exposed the improved footing subgrades to extensive frost risk. To combat this, when freezing weather was anticipated, forms were wrapped in concrete blankets the night prior to a concrete pour, and propane heaters were placed within the forms to elevate the temperature to the point where the foundation concrete was not placed on frozen subgrade. A photo taken during the foundation construction phase is shown in Figure 12.

Figure 12 – Foundation Construction
